# HITACHI

**VD Mechanism**  
**for D-550/720/850/900**  
**SDT-9600/9610/7785**

## SERVICE MANUAL

No. 1081

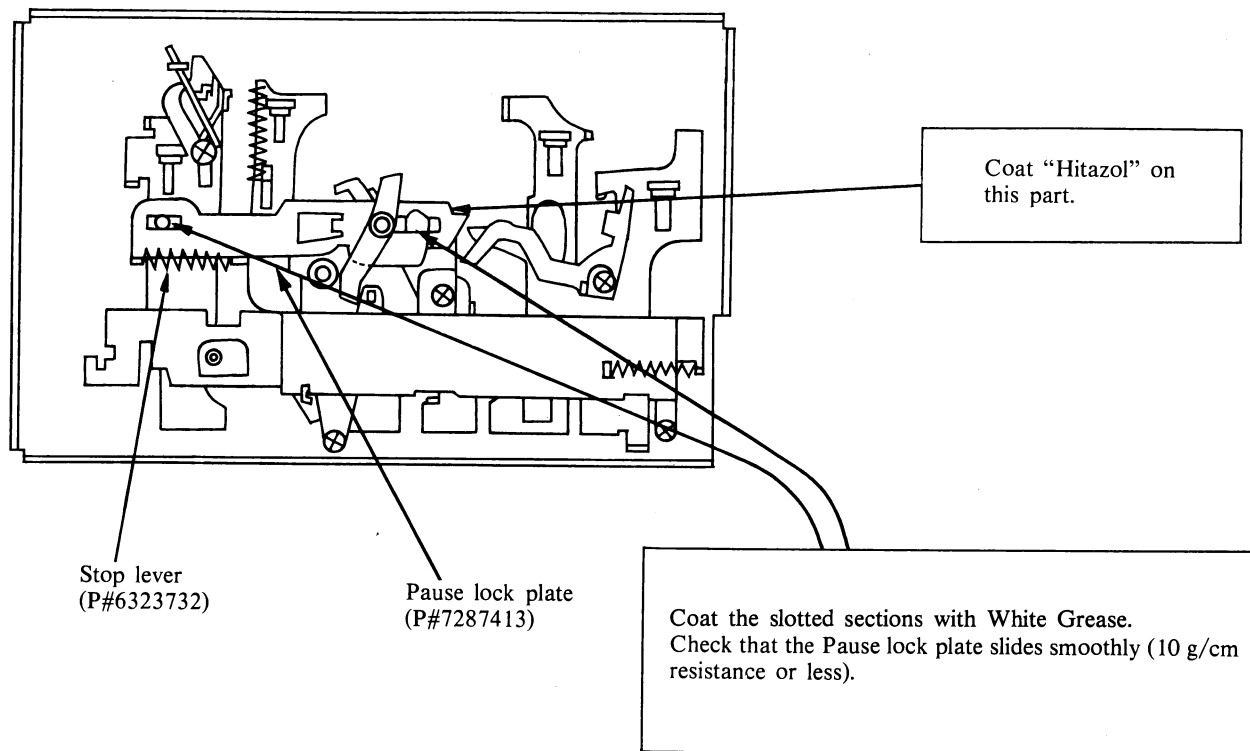
**Fig. 1 Adjustment of Pause Lock Plate**

| ITEM | SYMPTOM | CAUSE | REMEDY |
|---|---|---|---|
| 6. | Head plate does not lock and repeats vertical movement. | • Sliding movement of P lock plate faulty. | • Correct deformation of P lock plate and lubricate with oil. (See Fig. 1) |

(Related check item: A-6-1)

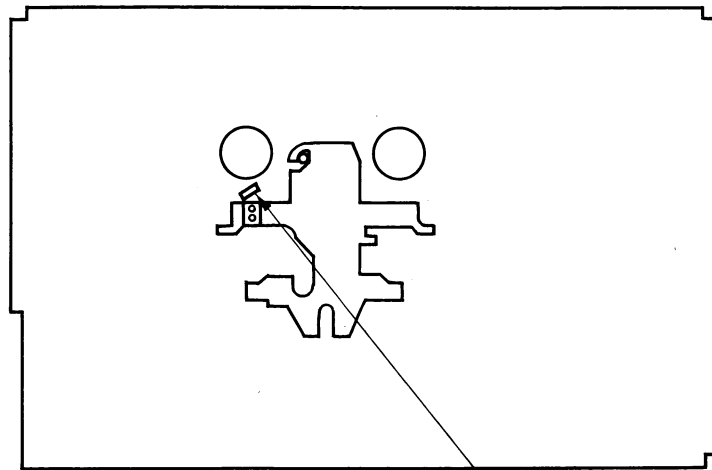
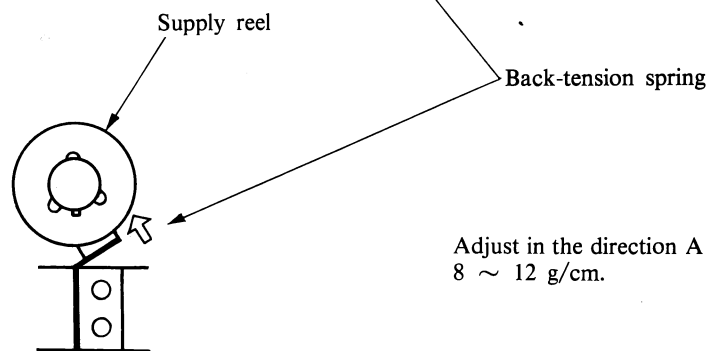
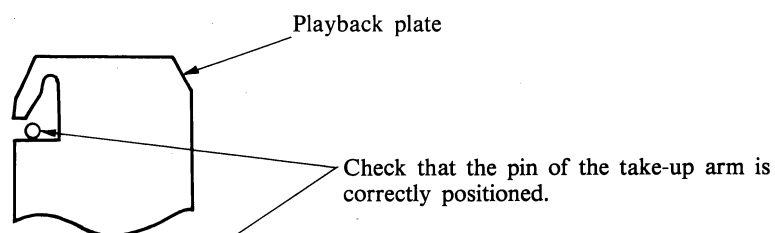
**Fig. 2 Back-tension Adjustment**  
(Related check item: B-4-1, C-5-1)

| ITEM | SYMPTOM | CAUSE | REMEDY |
|---|---|---|---|
| 4. | Tape is scratched.<br>Tape transport uneven. | 1) Supply-side back-tension too small.<br><br>2) PAUSE lever and pressure roller arm touch each other, so tape drive force too small.<br><br>3) Pressure-roller arm ass'y faulty. | 1) Correct back-tension plate (8 ~ 12g/cm) Fig. 2.<br><br>2) Replace PAUSE lever and P changeover arm.<br><br>3) Replace pressure-roller arm ass'y. |
| 5. | Take-up reel rotates during REW operation. | • Take-up arm pin displaced from PAUSE lever notch. | • Insert it in normal position. (See Fig. 2.) |

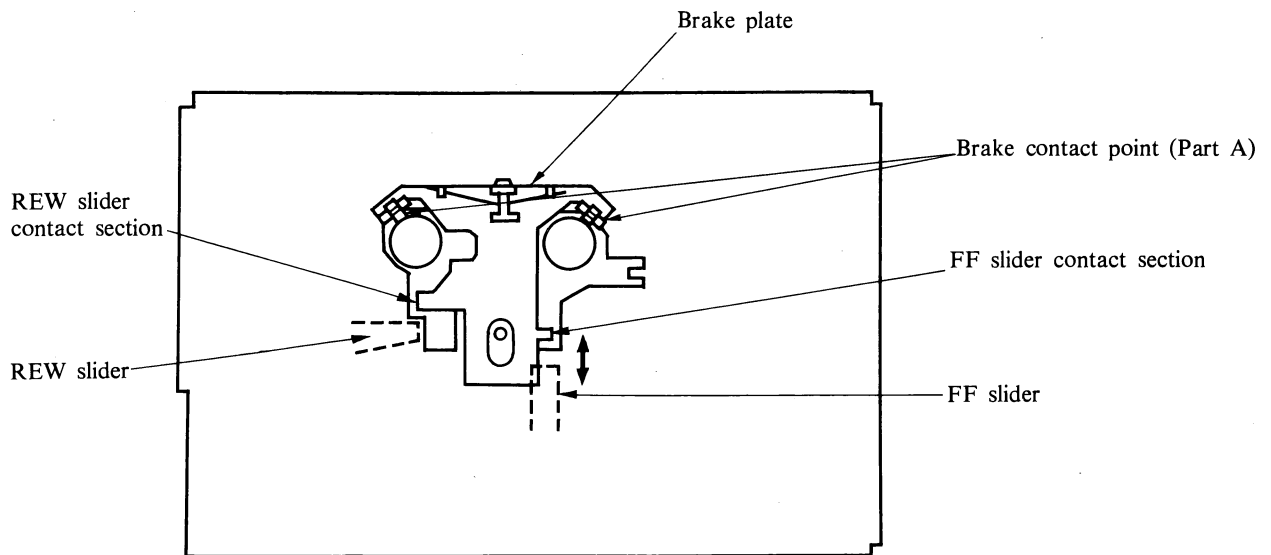
**Fig. 3 Adjustment of Brake Plate**  
(Related check item: C-4-1)

| ITEM | SYMPTOM | CAUSE | REMEDY |
|---|---|---|---|
| 4. | Rotation speed changes during FF/REW operation. | 1) Brake plate deformed and touches reel<br>2) Mounting of cassette faulty, causing slippage between clutch and hub. | 1) Correct brake plate. (See Fig. 3)<br>2) Same as in B-5-1. (See Fig. 5.) |

Check whether or not the parts of the brake, which are compressed and bent up by the FF slider, and REW slider are deformed. If deformed, remove them and correct. When the FF or REW button is depressed, there should be a gap of more than 0.5 mm at part A. Therefore check, that with a gap at part A and with the FF or REW button depressed, actuation of the STOP mode brings part A into positive contact.

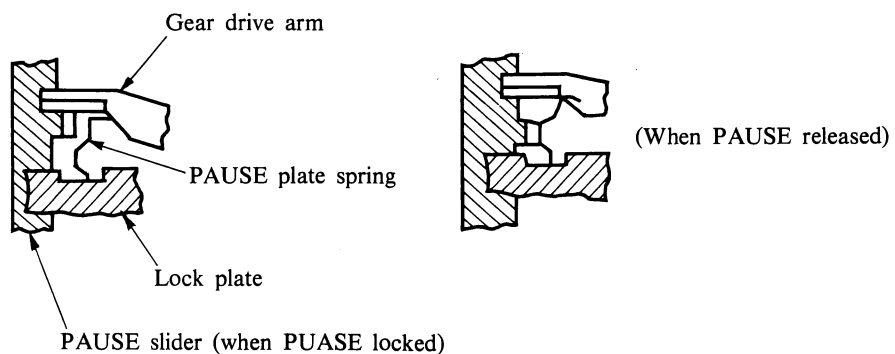
**Fig. 4 Pause Plate Spring Adjustment**  
(Related check item: A-2-1)

| ITEM | SYMPTOM | CAUSE | REMEDY |
|---|---|---|---|
| 2. | Head plate and all operation buttons are locked. | 1) PAUSE plate spring faulty.<br>2) Power assist mechanism operation faulty.<br>3) Sliding of lock plate (1) faulty. | 1) Adjust PAUSE plate spring.<br>2) Same as in A-1-3.<br>3) Correct deformation of lock plate (1), lubricate with oil, correct slide cover installation (Is the collar inserted?, Is there any deformation caused by over-tightening?). |

The PAUSE plate spring must come away and the gear drive arm must be made inoperative temporarily.

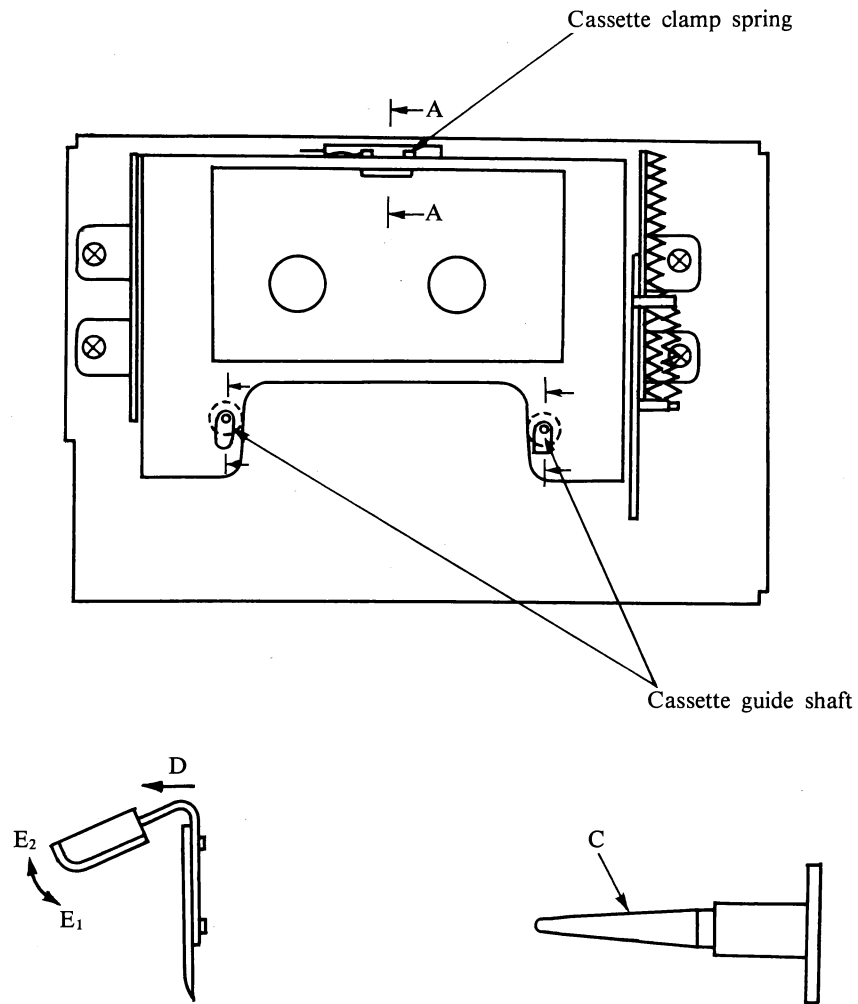
**Fig. 5 Cassette Tray Adjustment**

| ITEM | SYMPTOM | CAUSE | REMEDY |
|---|---|---|---|
| 5. | Tape crushed. | 1) Cassette holding faulty.<br>2) Pressure-roller arm ass'y faulty. | 1) Correct cassette clamp spring. Fig. 5.<br>2) Same as in B-4-3. |

| ITEM | SYMPTOM | CAUSE | REMEDY |
|---|---|---|---|
| 3. | Cassette cannot be inserted completely and is lifted up. | 1) Cassette clamp spring positioned incorrectly. (Right side displaced upward.)<br>2) Cassette guide shaft surface finish | 1) Same as in B-5-1. (See Fig. 5.)<br>2) Coat a little silicone grease onto upper surface of guide shaft.<br>See Fig. 5.) |

When the top of the cassette cannot be inserted completely into the tray, bend the spring while lifting the cassette clamp spring in direction D.

When the cassette is caught by the cassette clamp spring and is retained during the EJECT operation with the cassette still inserted, this is because the spring is bent too much in direction E<sub>1</sub>. Bend it slightly in direction E<sub>2</sub>.

When the bottom of the cassette catches on the cassette guide shaft, grease part C, which the cassette touches, very lightly with gauze using silicone grease and wipe it off leaving only a trace of grease.

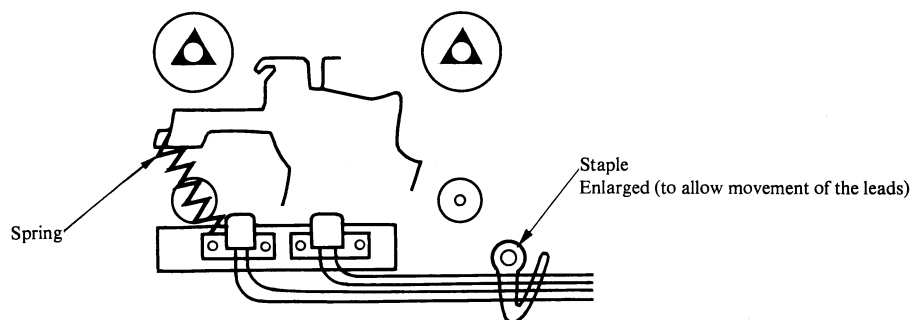
Due to hardening of the head lead wires at low temperatures some heads do not advance to the normal position on pressing the playback button, therefore the head plate spring has been changed. In addition, at the same time as spring replacement, the wiring clamp shown in the figure below has been enlarged to allow freedom of movement of the leads.

| No. | Parts No. | Description | FOR Y<br>Japan | * | Parts No. | Description | FOR Y<br>Japan |
|---|---|---|---|---|---|---|---|
| | 6302221 | Spring | | $\overrightarrow{A B}$ | 6324436 | Spring for D-550AU/RW/<br>W/BS/FS/U D-720C/RW<br>SDT-7785E/F/S | |

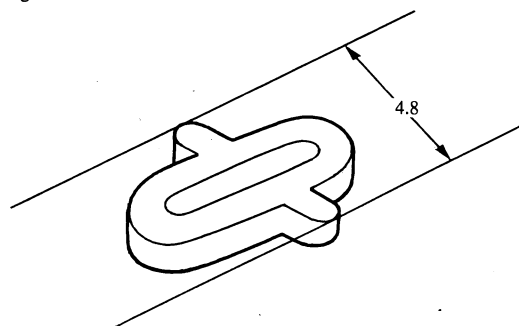
During prolonged used of the pause function, low brake torque causes tape slackness to occur; therefore the brake rubber has been modified.

| No. | Parts No. | Description | FOR ¥ Japan | * | Parts No. | Description | FOR ¥ Japan |
|---|---|---|---|---|---|---|---|
| | 6586072 | Brake rubber | | AB | 6586071 | Brake rubber for D-550AU/<br>RW/W/BS/FS/U<br>D-850U/C/BS/FS/W/AU<br>SDT-7785E/F/S | |

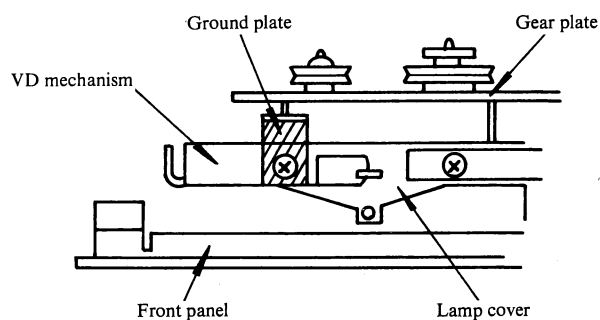
Electrical discharge noise which is caused by the charge generated by friction produced during rotation of the take-up pulley and fly-wheel belt pulley, etc. is cured by installation of a ground plate, as detailed below.

To mount the ground plate: Remove the screw at the left side of the lamp cover, and insert the ground plate between the VD mechanism and the lamp cover. Tighten the new assembly.

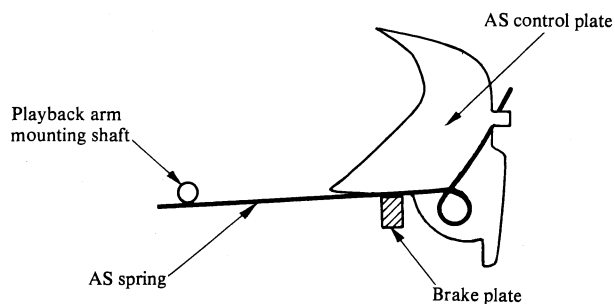
To improve the efficiency of installation and to prevent the spring shipping out of its location.

| No. | Parts No. | Description | FOR Y<br>Japan | * | Parts No. | Description | FOR Y<br>Japan |
|---|---|---|---|---|---|---|---|
| 1 | 7295951 | AS control plate | | $\overline{A} B$ | 6307924 | AS control spring for D-550AU/<br>RW/W/BS/FS/U<br>SDT-7785 | |
