Hi-Fi Products Service Bulletin

Model: All CDP/CDP-C

No. 286R1

Subject: Will Not Play Disc / Skips After Optical Block Replacement

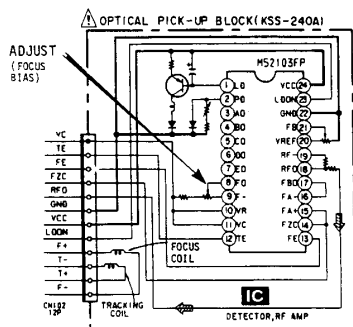
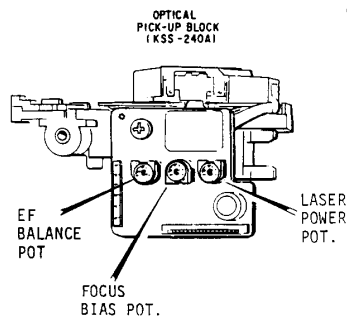
Symptom:
(12) Unit will not read TOC or unit will skip after optical block has been replaced.

Clear RF signal waveform means that the shape "◇" can be clearly distinguished at the center of the waveform.

Solution: Focus Bias is out of adjustment. Adjust focus bias pot on optical block KSS-240A as follows:

1. Use a YEDS-18 disc.
2. Adjust the focus bias pot for the clearest eye pattern.
