Hi-Fi Products  
Service Bulletin

**Model:** CDP-68/307ESD/750/950

**No.** 32

**Subject:** No Chucking Operation

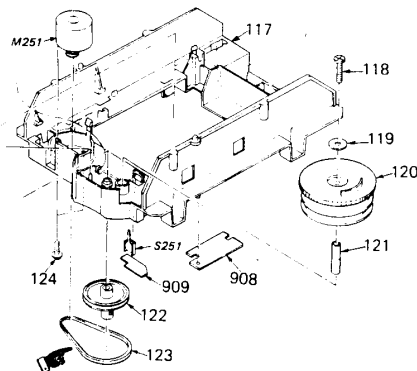
During the loading cycle, the disc will not be completely chucked. The optical section may swing upward only partially or perhaps not at all.

**Cause:** This is caused by the drive belt slipping.

**Solution:** Replace the former drive belt with a newer version drive belt. The part number is listed below:
