Hi-Fi Products  
**Service Bulletin**

**Model:** CDP-510/910/505ESD

**No. 25**

**Subject:** Intermittent No Eject

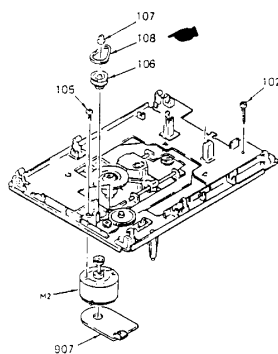
**Note:** Diagram shown is for the CDP-510.

Loading tray is intermittently not ejected.

**Solution:** Replace the driving belt with the new one as shown:
