## Hi-Fi Products Service Bulletin

**Model:** CDP-C100/C15ESD/C9ESD/C90ES/C900  
/C910

**No. 311**

**Subject:** New Type Disc Magazine Will Not Eject

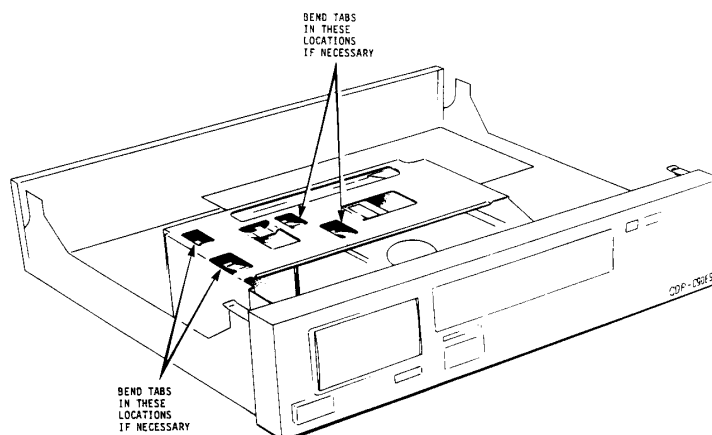
The new type XA-10B disc magazine will not eject from the unit consistently.

Since the new type XA-10B disc magazine has a slightly higher profile, you must bend the tabs on the mechanism housing (see drawing) which are located just above where the cartridge is inserted into the machine to provide clearance.

*Note: Bend tabs to the point where the disc magazine will consistently eject from the unit.*
