Hi-Fi Products
Service Bulletin

Model: TC-FX6/-FX1010/-K555/-555ES

No. 185

Subject: New Motor Does Not Turn

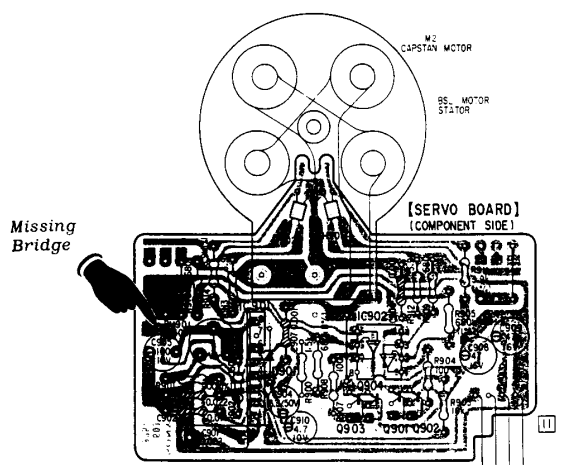
After replacing the capstan motor M2 (P/N X-3575-308-0), the motor does not move upon power up.

Solution: A solder bridge is missing. Replacing the bridge will solve the problem.
