# Hi-Fi Products Service Bulletin

**Model:** TC-K700ES

**No.** 7

**Subject:** Improvement of Wow and Flutter

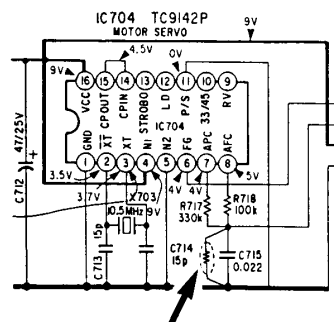
**【System Control Board】**

Wow and flutter is generated just after play is initiated.

Add an 820K $\Omega$  resistor (P/N 1-215-491-00) in parallel with C715 on the system control board.

Mount a 820K $\Omega$  resistor here
