Hi-Fi Products  
**Service Bulletin**

**Model:** CDP-C225 / C325 / C425

**No. 319**

**Subject:** Portions Of The Display Are Constantly Lit

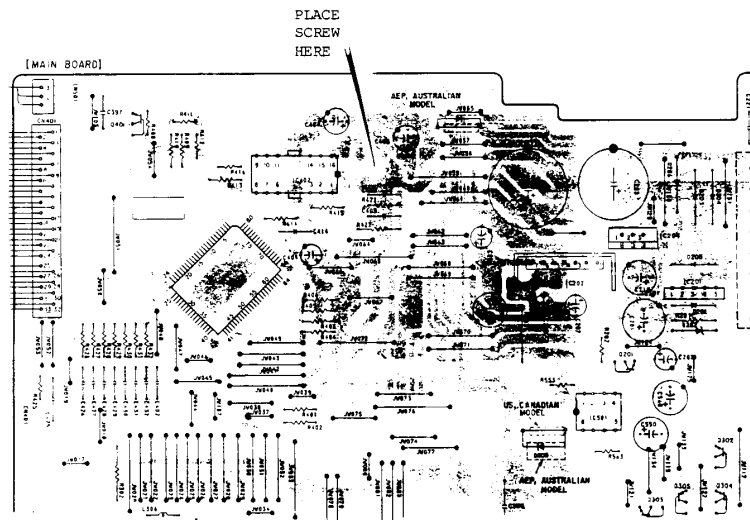
Portions of the display are constantly lit when the unit is powered on. The Main PC board becomes loose from the finger snap hold down which holds it to the chassis. This results in the Main PC board shorting to the bottom metal case which causes problems with the display.

Snap the Main PC board back onto the finger snap hold down and add a screw (type shown in the chart below) at the location shown in the drawing below.

| DESCRIPTION | PART NUMBER |
|---|---|
| SCREW TAP +BV 3.0X8.0 BLK | 7-685-646-79 |
