Hi-Fi Products  
**Service Bulletin**

**Model:** CDP-C401/500

**No. 92**

**Subject:** No Tray Operation

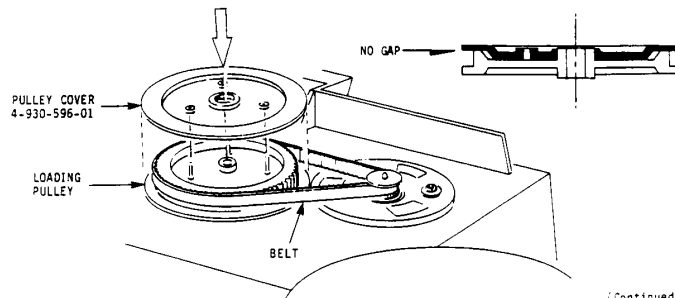
Tray does not open. The loading belt has slipped off.

1. Remove bottom panel.

2. Re-install belt.

3. Install Pulley Cover on the Loading Pulley.
