# Hi-Fi Products Service Bulletin

**Model:** STR-VX550

No. 3

**Subject:** Missing 1S1555 Diode

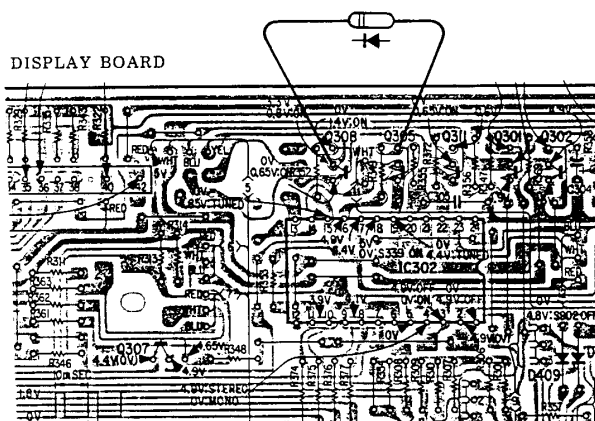
(151)  
Early production of STR-VX550 diode 1S1555 was omitted from the display board.

Add Diode 1S1555  
Part No. 8-719-815-55

**Solution:**  
When servicing STR-VX550, check if this diode is installed. If the diode is missing, solder a 1S1555 between collector of Q308 and base of Q305. The cathode should be connected to the collector of Q308.
