TECHNICAL

K2000 Modification List

Changes for the K2000

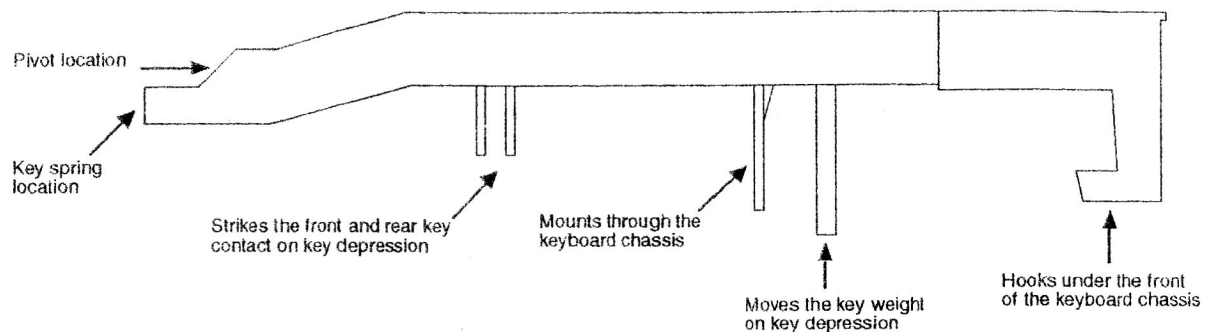
Natural/White Key, Keyboard MD

DIFFERENCE BETWEEN FATAR MD & MDF KEYS

- Generally you will find keyboards produced after April of 1998 to have the MDF style keys and weights.
- When ordering a key or keyweight from Kurzweil you should always have the serial number of the keyboard handy for verification.

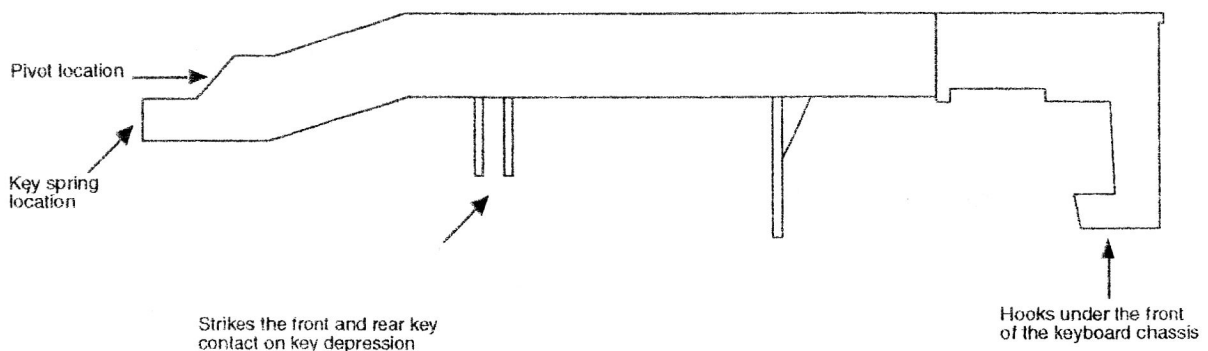
Natural/White Key, Keyboard MDF

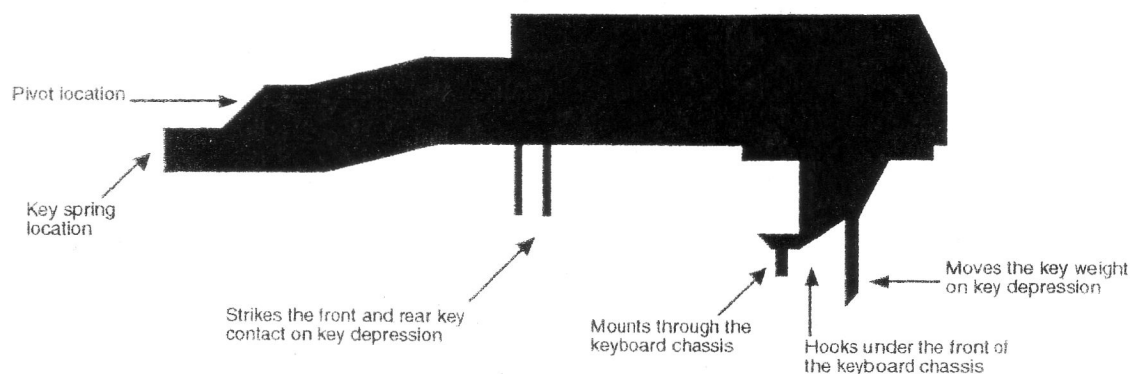
Sharp/Black Key, Keyboard MD

DIFFERENCE BETWEEN FATAR MD & MDF SHARP KEYS

- Generally you will find keyboards produced after April of 1998 to have the MDF style keys and weights.
- When ordering a key or keyweight from Kurzweil you should always have the serial number of the keyboard handy for verification.

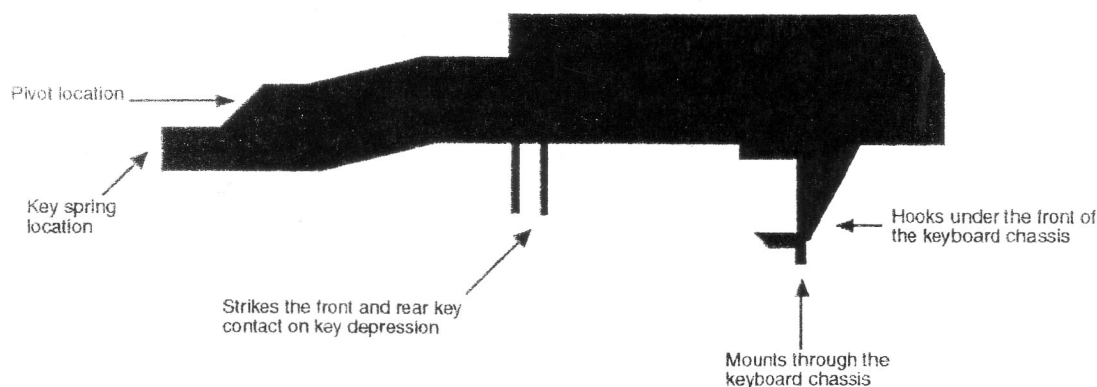
Sharp/Black Key, Keyboard MDF

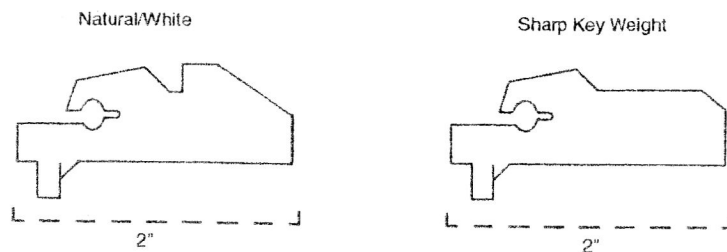
Natural/White and Sharp/Black Key Weights, Keyboard MD

DIFFERENCE BETWEEN FATAR MD & MDF KEYS WEIGHTS

- Generally you will find keyboards produced after April of 1998 to have the MDF style keys and weights.
- When ordering a key or keyweight from Kurzweil you should always have the serial number of the keyboard handy for verification.

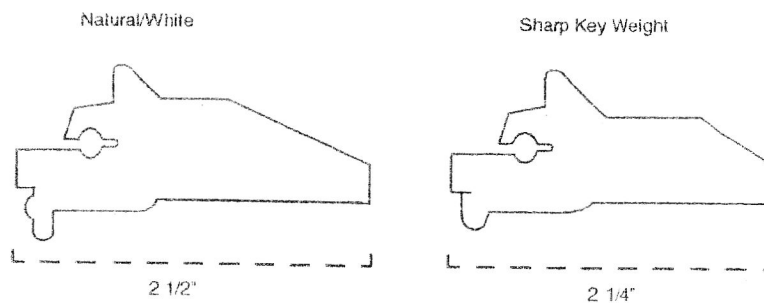
Natural/White and Sharp/Black Key Weights, Keyboard MDF
