PHILCO . . . . RADIO SERVICE BULLETIN No. 349

Supplementary to Bulletins No. 344, 345, 346, 347

FOR MODELS 715, 41, 44 and 408

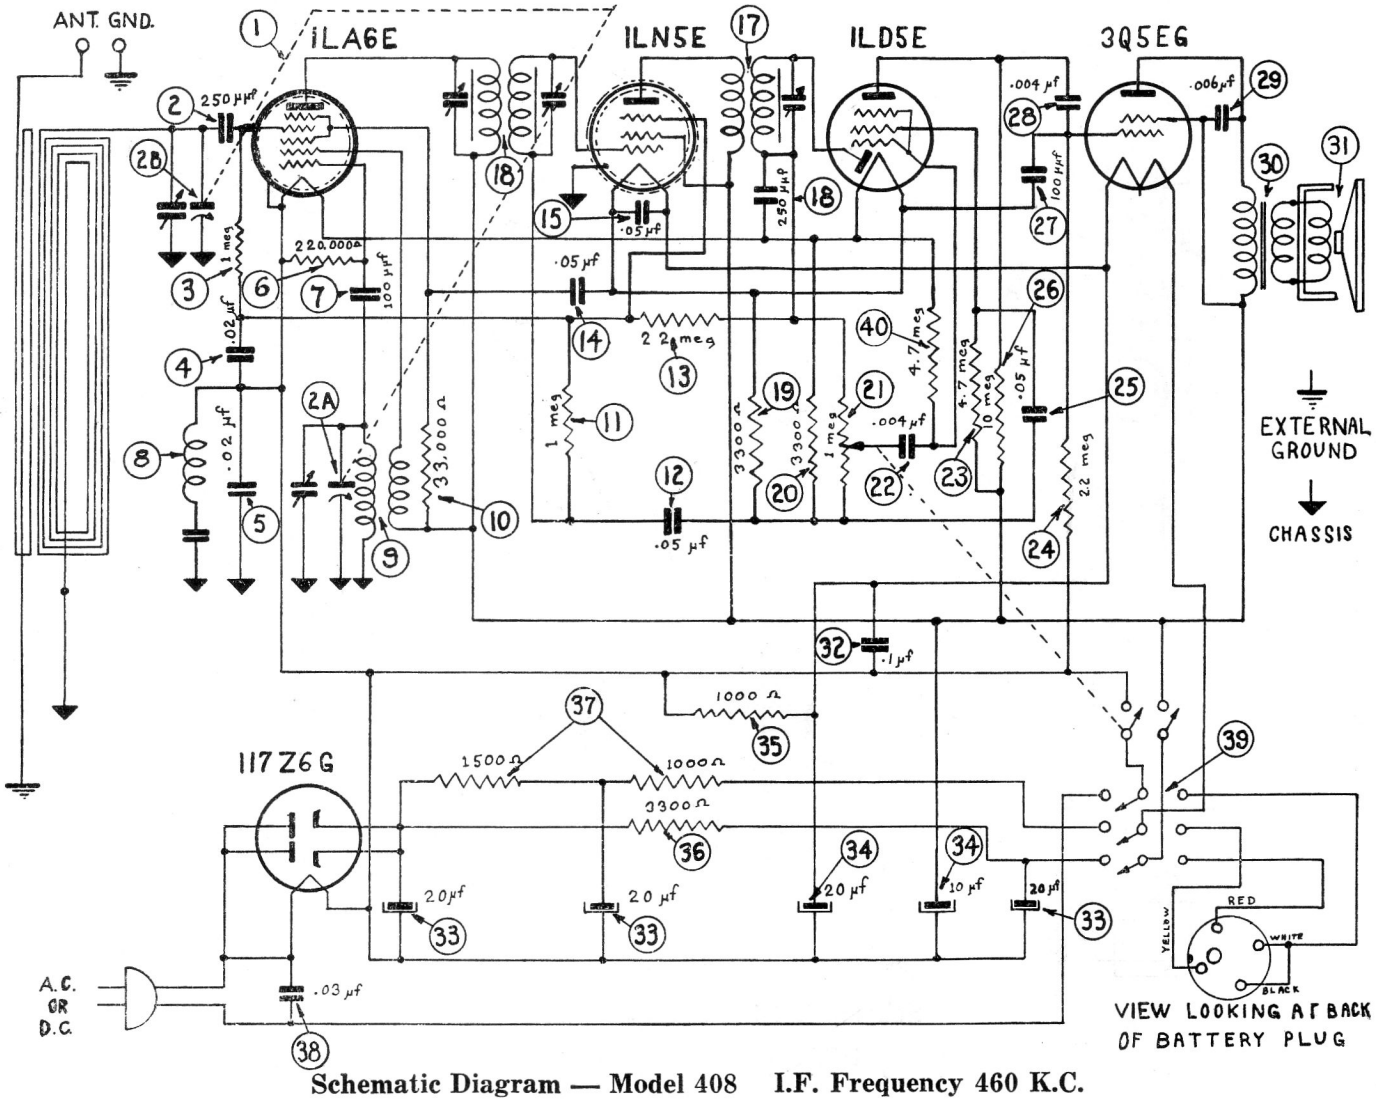
Schematic Diagram — Model 408 I.F. Frequency 460 K.C.

Various changes have been made in production on Philco Models 715, 41, 44 and 408 in order to improve their performance. The new schematic diagrams for these models are on the pages of this bulletin, and should be used instead of the similar diagrams appearing in bulletins numbered 344, 345, 346 and 347.
