**SERVICE MANUAL**

**AKAI SEMI-AUTOMATIC TURNTABLE**

MODEL **AP-003**

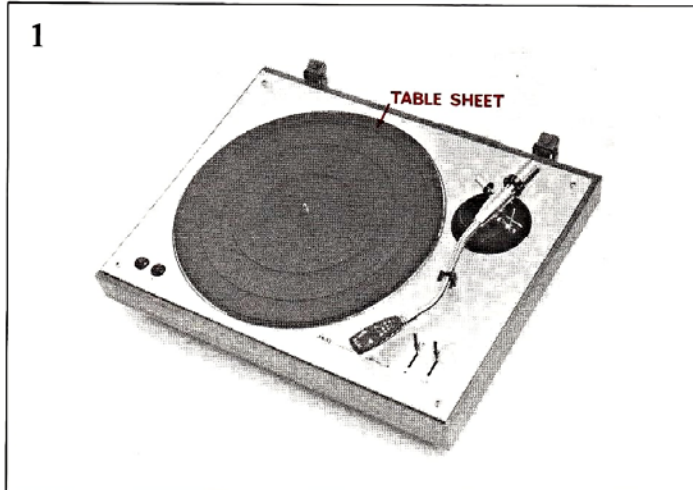
In case of trouble, etc. necessitating disassembly, please disassemble in the order shown in photographs. Reassemble in reverse order.
