Date 23.08.11	Ref. No. 07HA020	Revision 5	Type REACTIVE	IRIS 3510 C134 C510	Level 3	Source AU
Models STR-DA5300ES						
Subject: Various Symptoms [REVISION 5]

Various symptoms may occur when the STR is connected via HDMI.

Malfunctioning firmware.

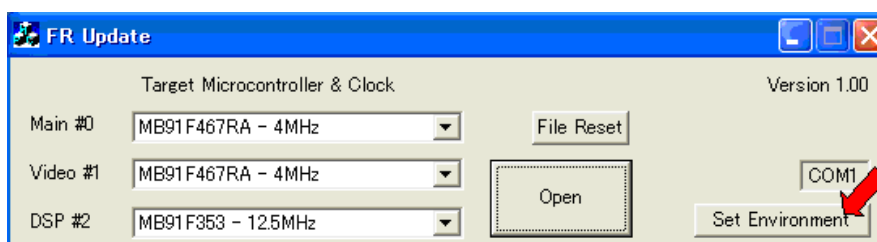
* Click [Set Environment] in the FLASH Writer Window.

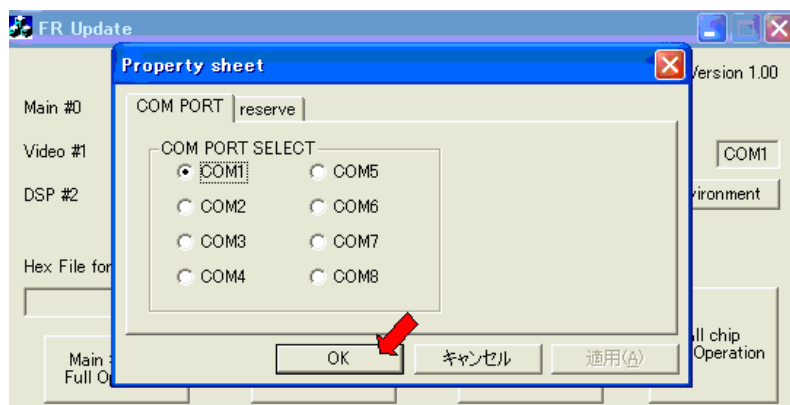
* Select the COM port to which you connected the RS-232C cable, and click [OK].

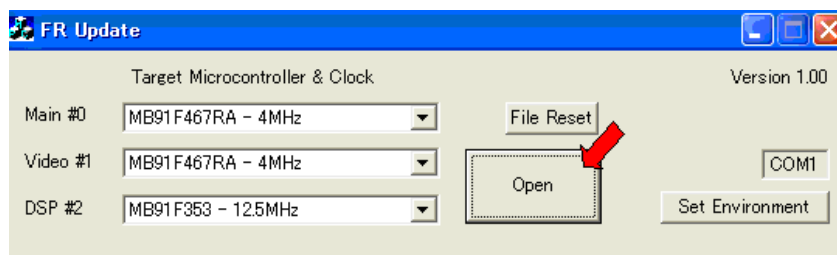
* Click [Open] in the FLASH Writer window.

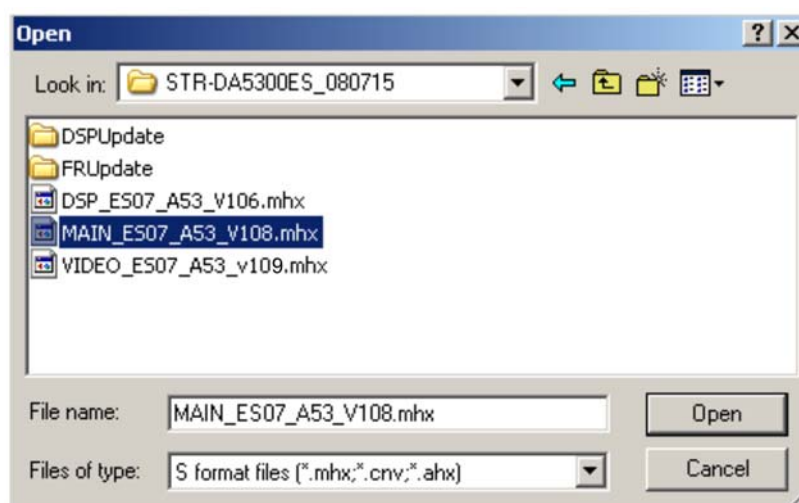
* Select and open the latest FLASH program file (MAIN_ES07_A53_V108.mhx) by clicking the [Open] button of the "Hex File".

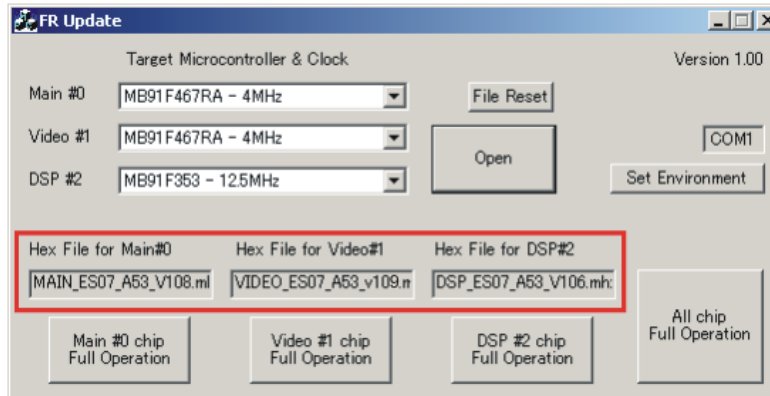
- * Confirm the firmware version on the FLASH Writer Window.
- * Make sure that the amplifier is powered on, and press [All chip Full Operation].

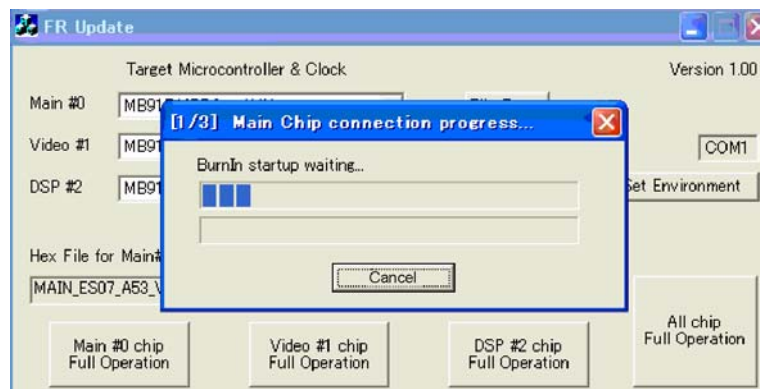
- * The upgrade will start and last for between five and six minutes. While overwriting, do not power off the amplifier or PC. The progress can be confirmed by the bar above the window.

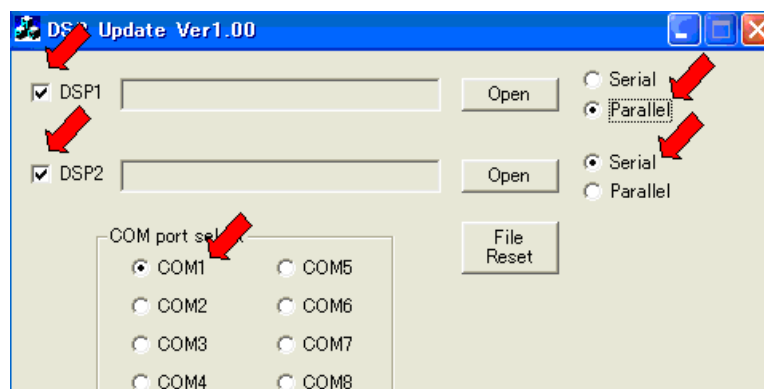
- * The DSP FLASH Writer Window will appear.
- * Check the checkbox of "DSP1" and "DSP2". Select "Parallel" for "DSP1" and select "Serial" for "DSP2".
- * Select the COM port to which you connected the RS-232C cable.

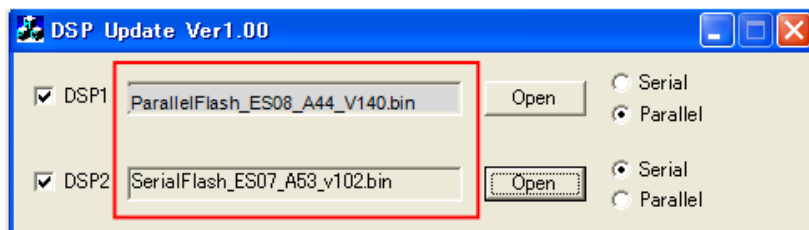
* Confirm the firmware version on the DSP FLASH Writer window.

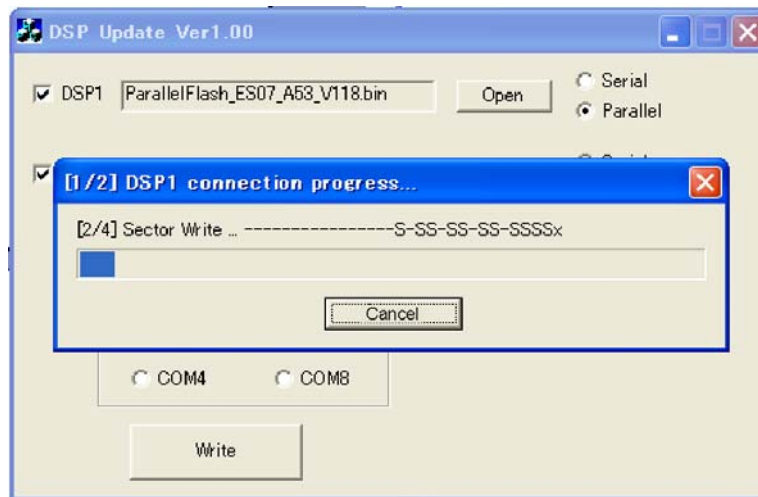
* Make sure the amplifier is powered on, and click the [Write] button in the DSP FLASH Writer window.
