Hi-Fi Products  
**Service Bulletin**

**Model:** CDPC425

**No. 381**

**Subject:** A Whistling noise is heard when playing certain discs.

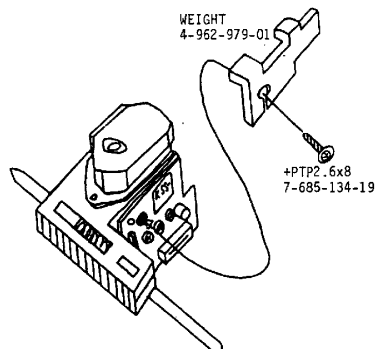
A whistling noise can be heard from the mechanical assembly. The whistling noise is a result of vibration of the disc, optical lens, and the BU base which results in resonance that causes the noise. This noise occurs only with certain discs.

To reduce the vibration of the BU base add the weight (4-962-979-01) to the optical block using a +PTP2.6X8 screw (7-685-134-19) in place of the original screw. See diagram below.
