# Hi-Fi Products Service Bulletin

**Model:** CDP-C445

**No.** 465

**Subject:** Drawer will not open

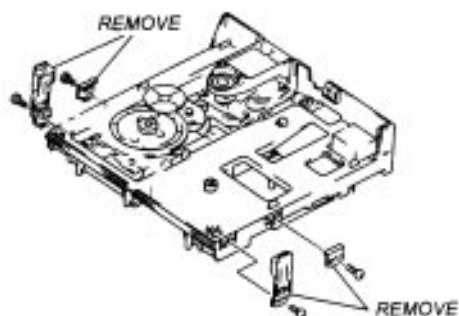
The Drawer will not open or open completely.

Remove the four screws holding the cabinet top. Lift the cover off of the unit. Remove the two large brackets located at the front of the unit. Remove the small brackets (see diagram).
