**Model:** STR-D565, STR-D665

**No.** 494

**Subject:** Noise in Rear Channel

**Date:** October 10, 1996

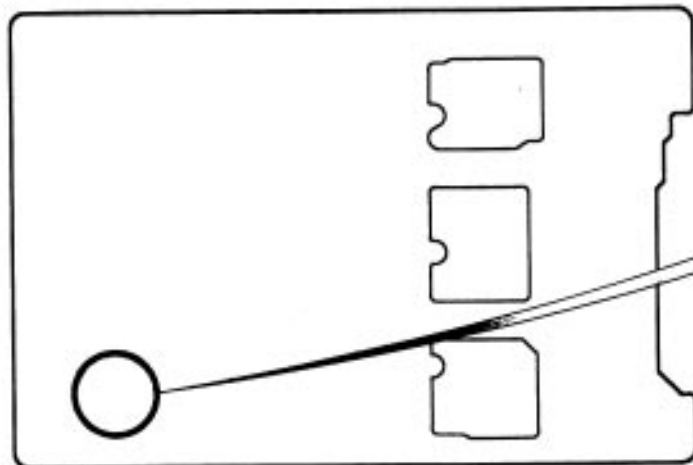
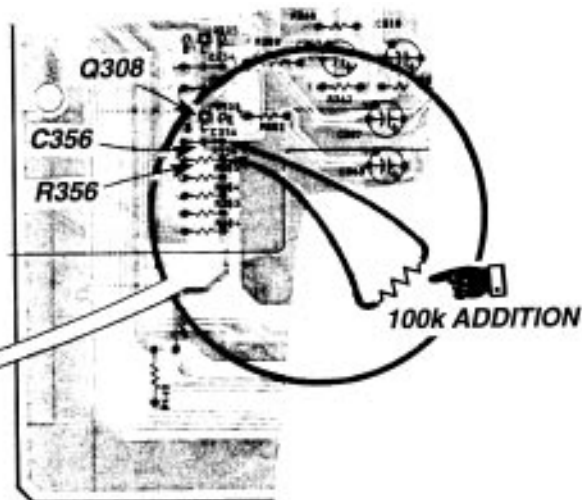
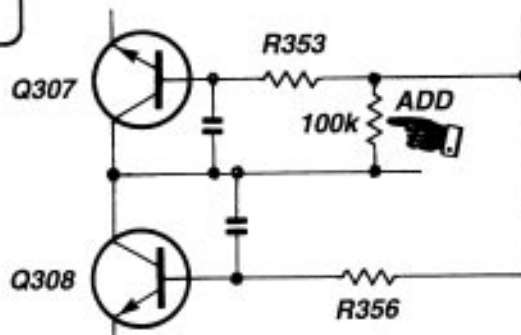
**MAIN BOARD**  
— CONDUCTOR SIDE —

The customer may complain of noise or distorted sound from the rear channel when the volume level is increased.

Add the following resistor as outlined below

| REF | DESCRIPTION | PART NUMBER |
| N/A | 100K OHM CARBON RESISTOR | 1-249-971-11 |
